Exhibit 2

DR Loss Consultants

Insured: Jeri McKenzie

Address of Property:
3424 MOUNT WASHINGTON
RD

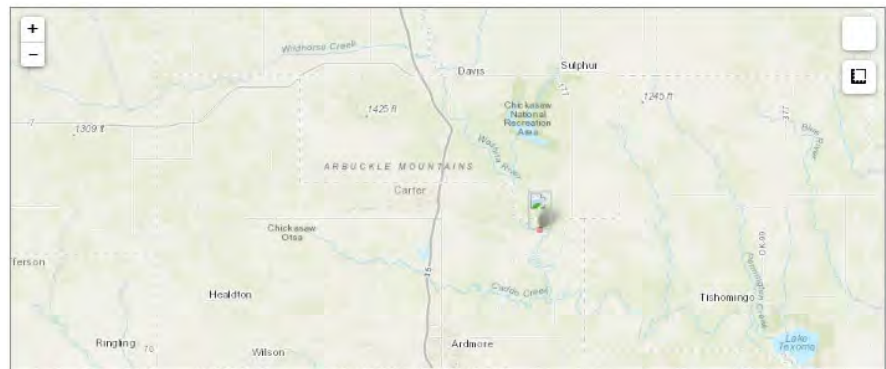
Event Map:

See Weather.US radar imagery of the storm event. Severe weather and hail are registered directly over the loss location.

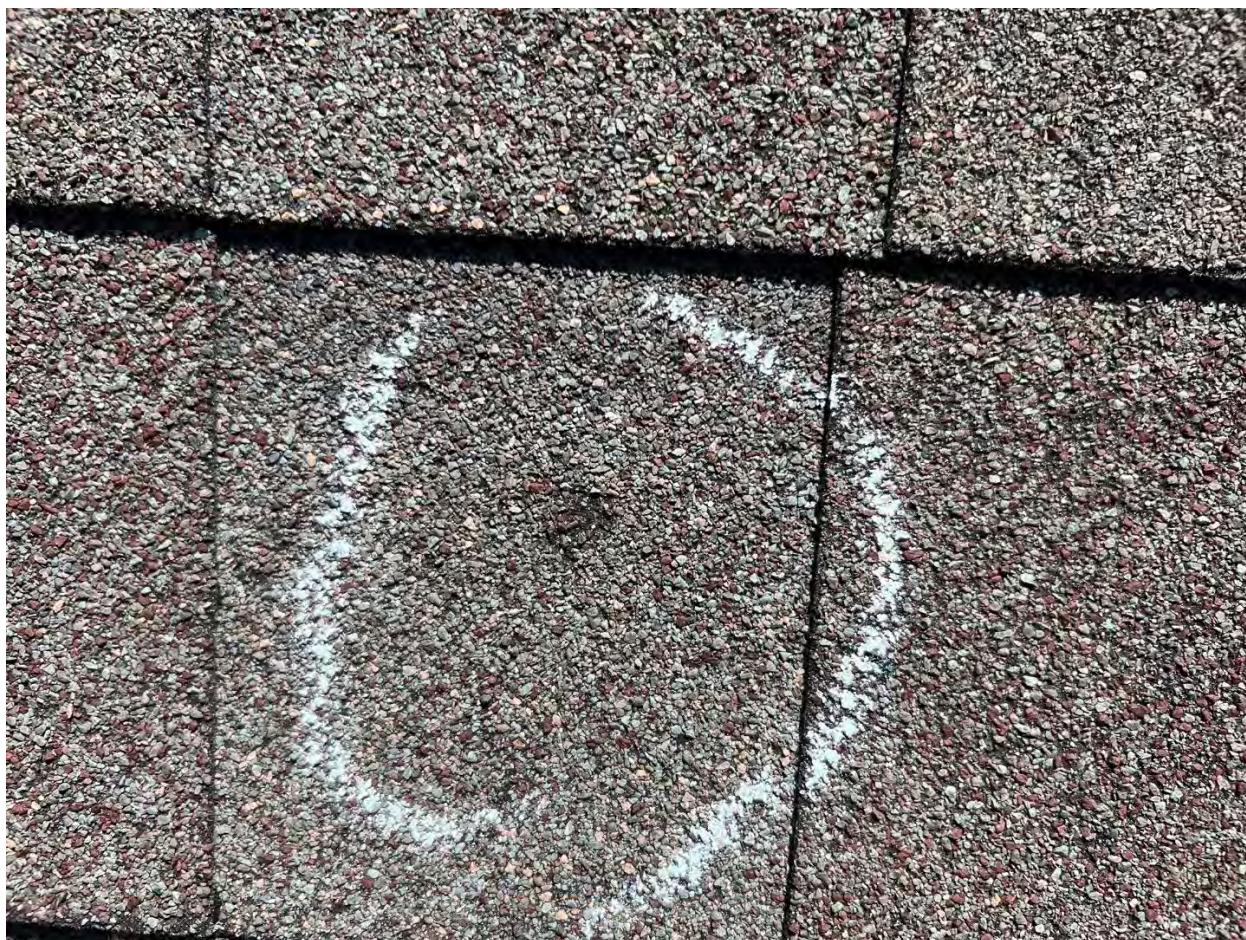
Hail damage example from this roof:

There are also some minor mechanical damages from foot traffic. These damages are clear and distinct from hail damage, as hail damage is typically round in shape, consistent occurring across directional slopes, as well as randomly positioned on the shingles, and can contain other evidence such as crushed granules or softened matting.

Hail damage was observed to the roof materials, gutters, and wood shutters on the front elevation of the home.

As a result of the hail and wind damage, full roof replacement is necessary along with all other items listed in my attached Exhibit B.

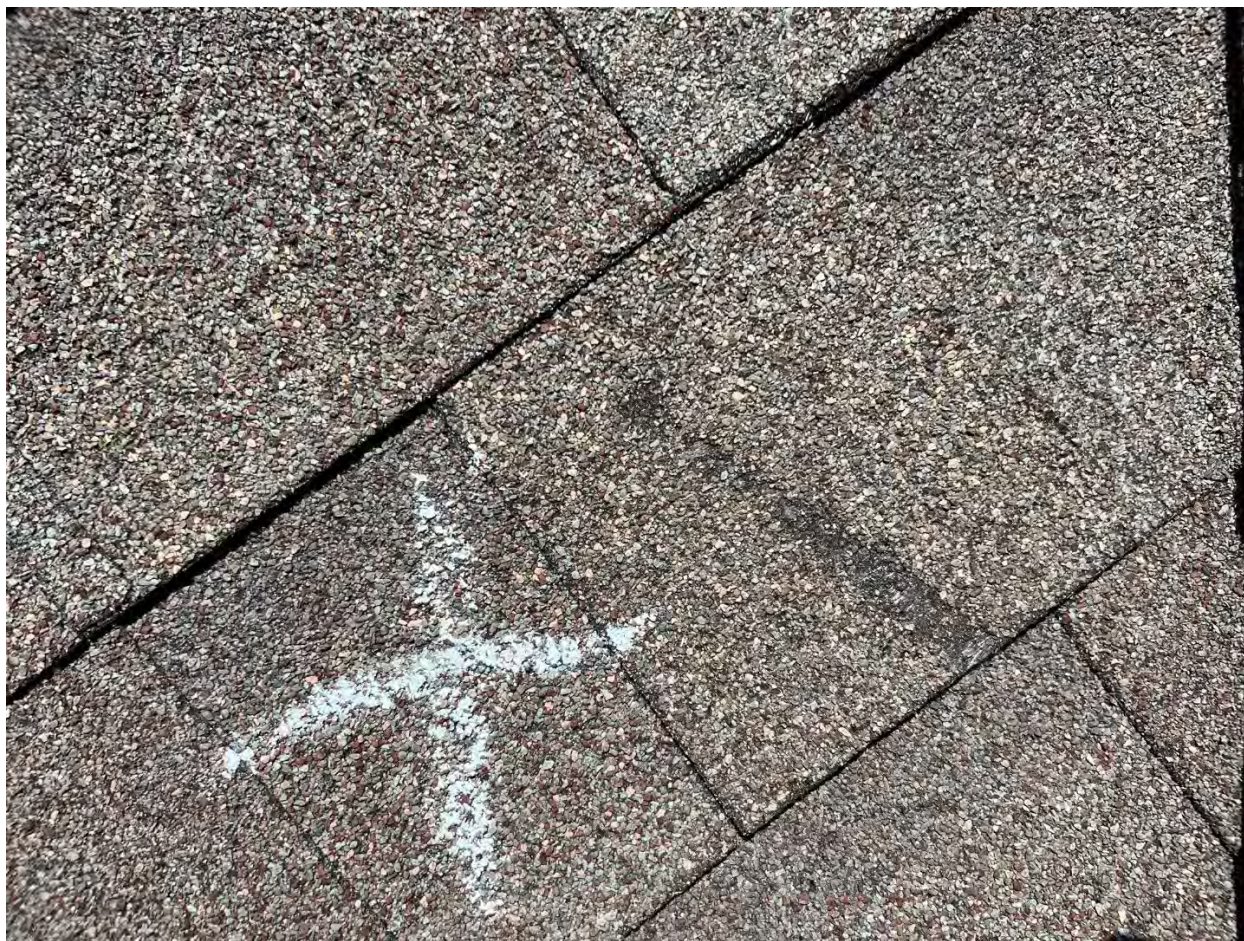
Foot traffic mechanical damage example from this roof:

The foot traffic was most notable in the valleys where foot traffic is most common to occur, as the valleys are the safest areas to ascend the roof.
